STRUCTURAL ASSESSMENT for the CENTENNIAL BAPTIST CHURCH

Helena, Arkansas

March 19, 2021

Structural Assessment by STRATA Architecture Inc. and Structural Engineering Associates, Inc.

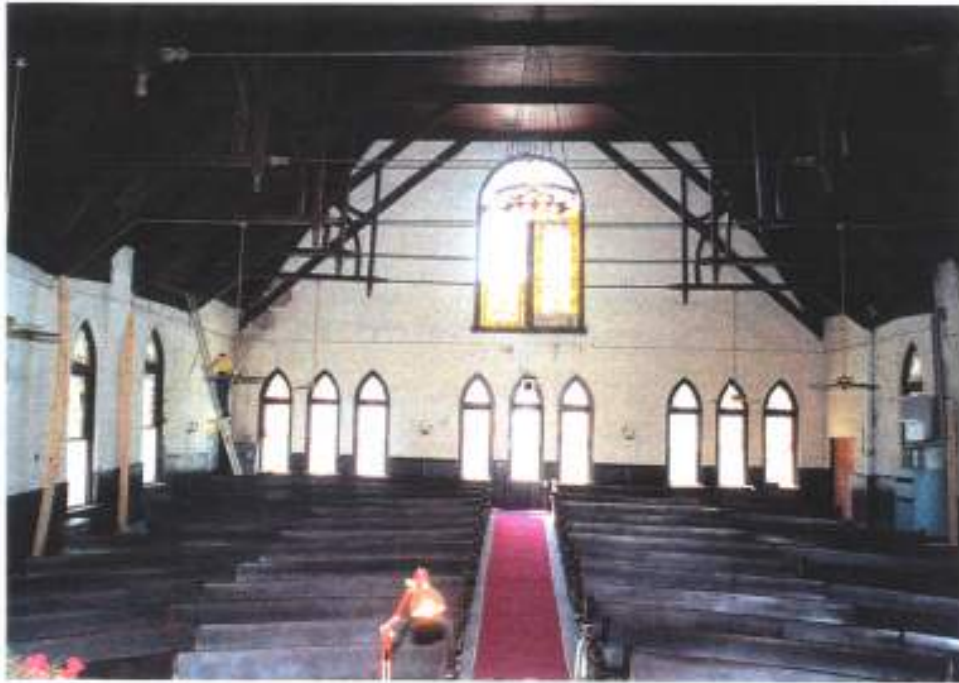
Figure 1.5. Interior view of the sanctuary looking west, note the bowed triple 2x6 temporary supports at the south (left) wall. (Photograph from the 1994 Jameson report).

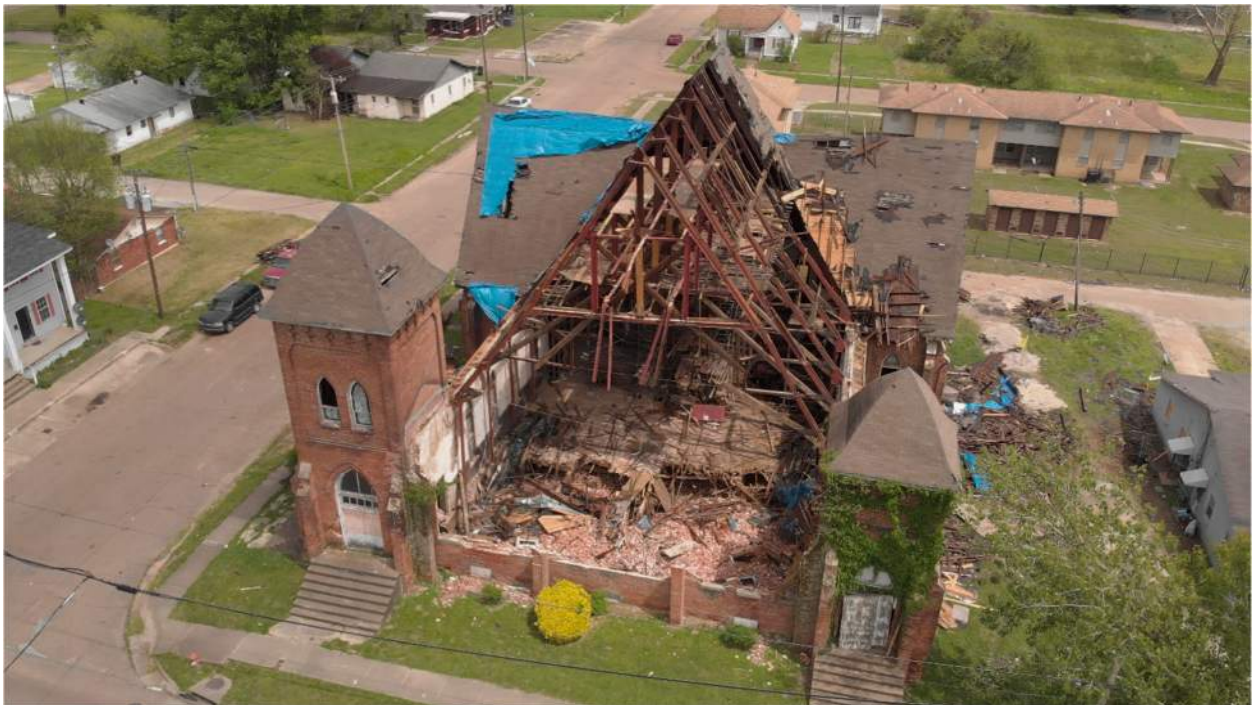
In April of 2020, a straight-line windstorm damaged the structure causing the west gable façade to collapse into the nave. Much of the roof was ripped away, exposing the roof trusses and the interior of the church (Figure 2.1).

Figure 2.1. Drone photo following collapse, looking east at west façade collapse.
(Courtesy Amoz Eckerson and Nolan Dean, 2020)

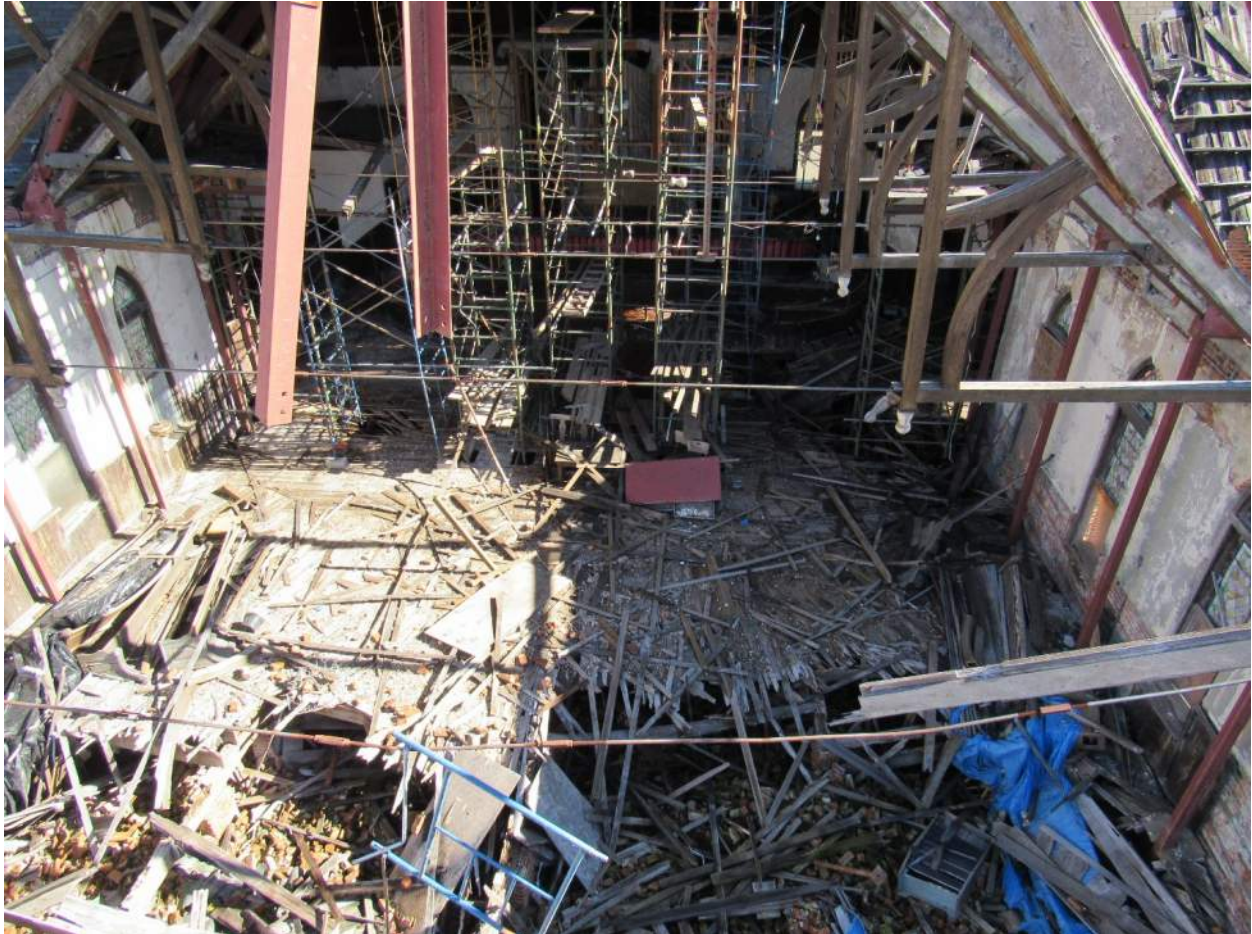
From the aerial lift over the nave, it was observed the west wall debris crashed through a portion of the floor framing into the crawlspace below.

Figure 2.3. Looking down into nave from aerial lift. (SEA 2020)

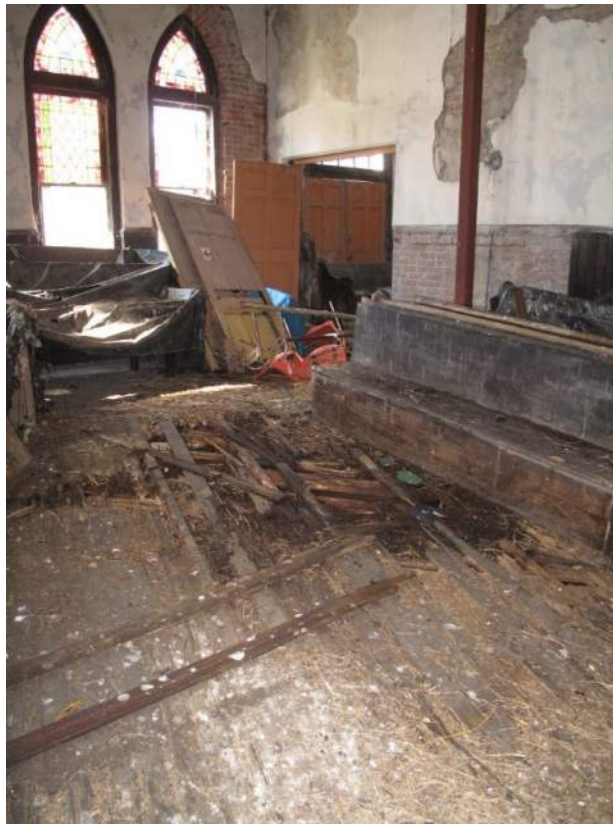
Prior to the structural collapse, the floor framing and flooring was in very poor condition. There was severe rot due to moisture and possibly insect damage. Photos taken during the previous repairs show supplemental posts and beams supporting the floor framing below the nave (Figure 2.4). Other photos also show the flooring covered in bird excrement and severe rotting of the floor below openings in the roof.

Figure 2.4. Severe flooring deterioration in nave prior to collapse.
(Courtesy Tommy Jameson, 2017)

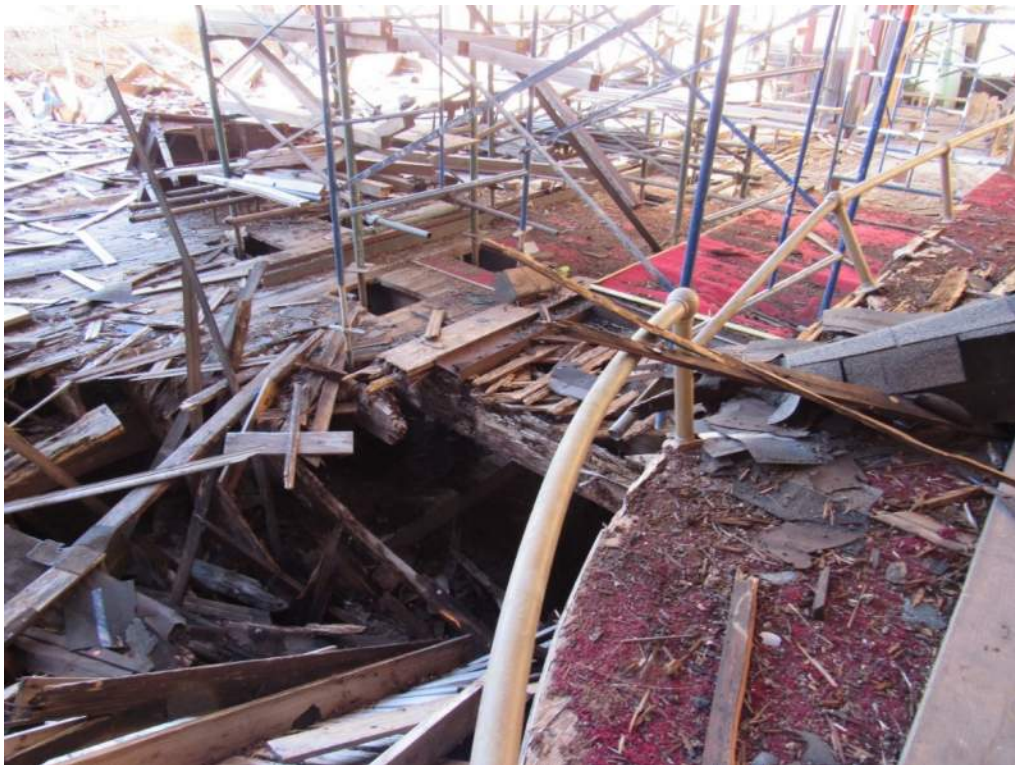
Photos taken during the 2020 assessment show the severe deterioration of the floor joists and flooring, which was a longstanding condition prior to the collapse (Figure 2.5).

Figure 2.5. Collapsed and deteriorated first floor framing in the transept. Scaffolding going through floor supporting overhead trusses. (SEA 2020)

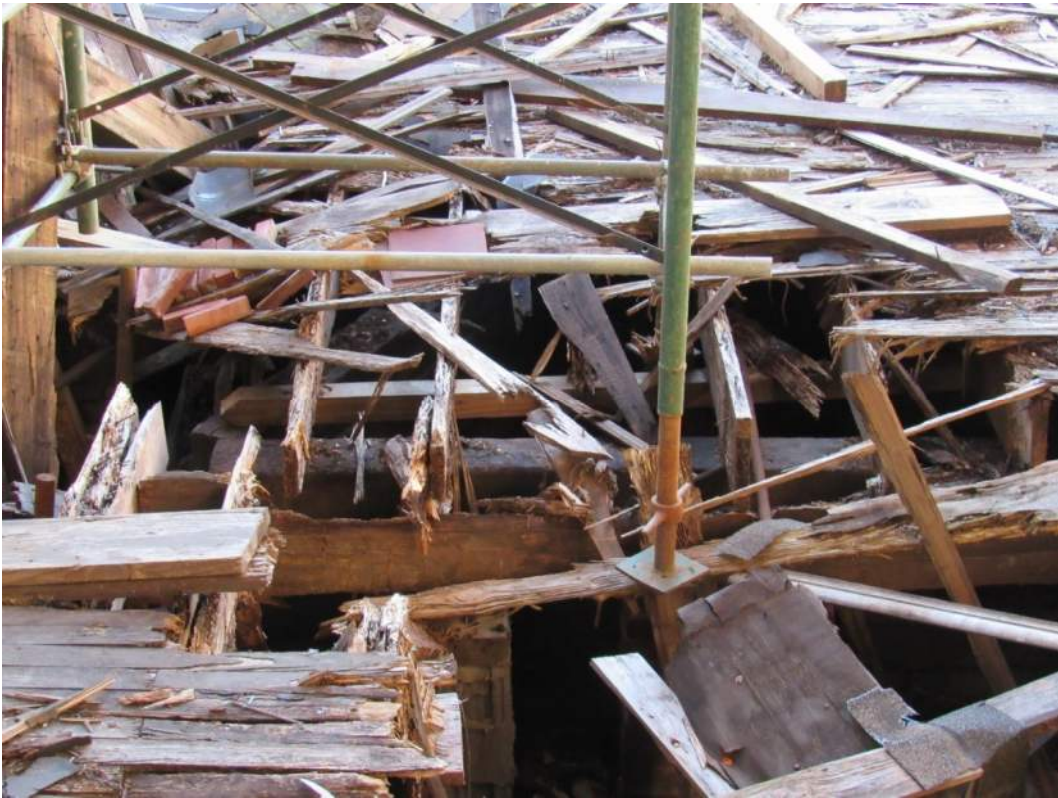
Additionally, penetrations were made through the flooring for the use of scaffolding in the truss repair projects. Some of this scaffolding is still in place below truss T-5. There is additional scaffolding bearing on the original wood flooring and floor framing alone, with no direct load

Figure 2.6. Collapsed and deteriorated floor on the south portion of the transept. Note scaffolding supported by the wood floor. (SEA 2020)

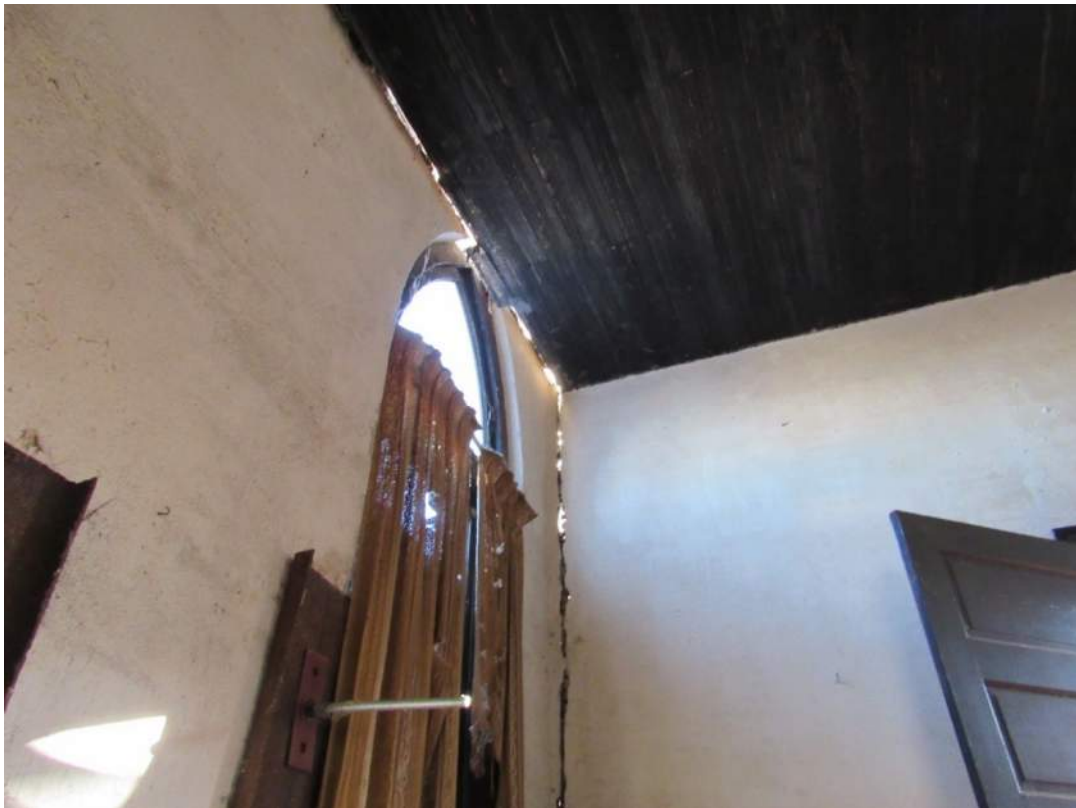
There are interior rooms in the northeast and southeast corners of the transept. Where the interior walls of these rooms intersect with the exterior brick walls, there are large cracks and settlement of the interior walls indicating differential movement between the interior and exterior walls (Figure 2.7). Based on earlier photos, this has been a longstanding issue for the structure.

Figure 2.7. Wide gap between interior wall and east transept exterior wall. (SEA 2020)

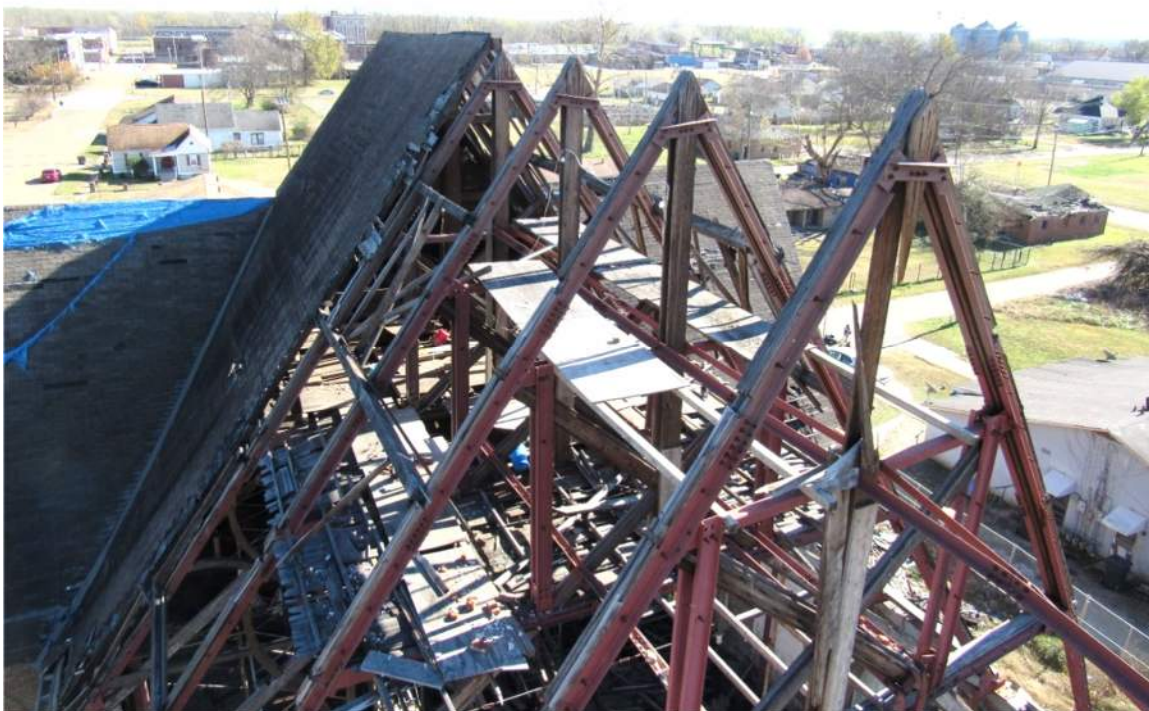
Figure 2.8. Exposed nave trusses viewed from aerial lift. (SEA 2020)

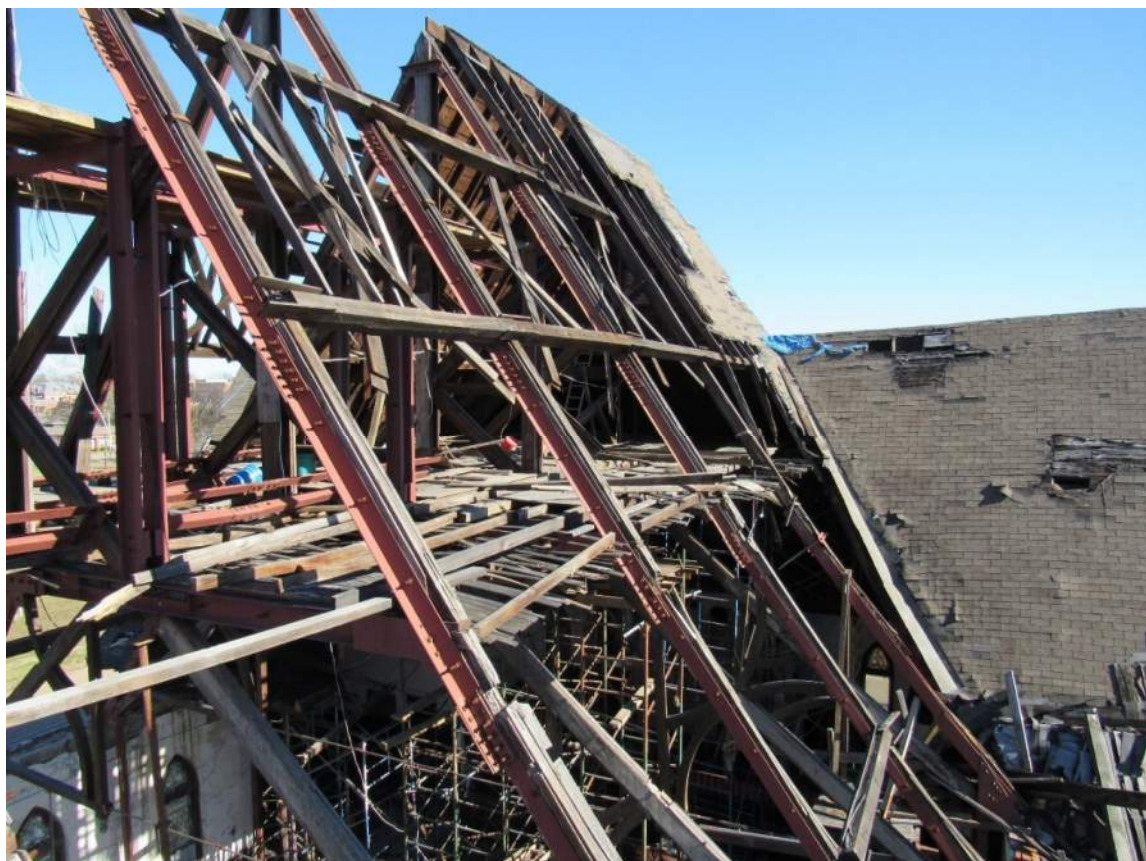
Figure 2.9. Exposed nave trusses viewed from aerial lift. (SEA 2020)

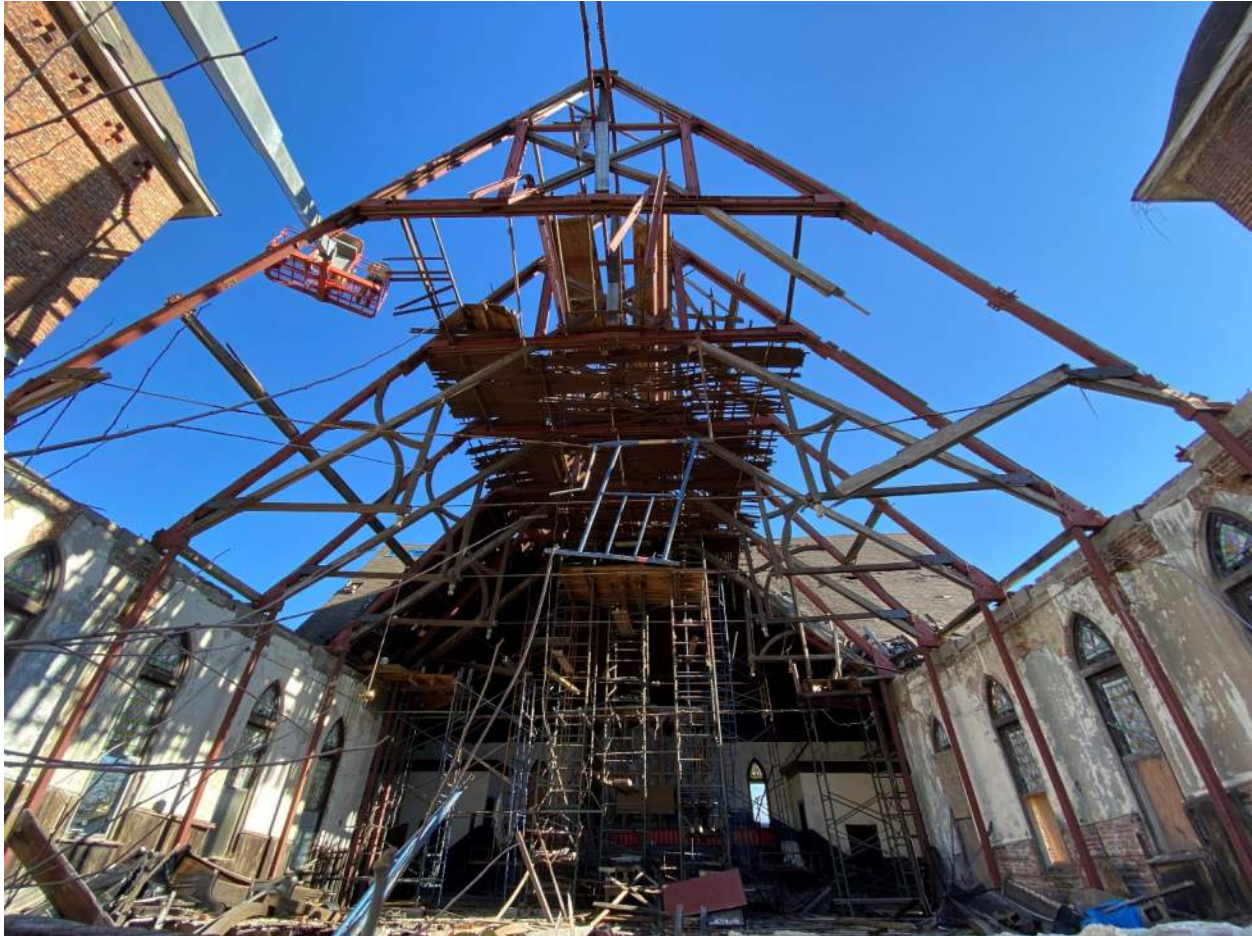
The western-most truss of the nave, truss T-1, is severely damaged and distorted, but still standing following the storm (Figure 2.10). The steel columns have pulled inward from the masonry walls, pulling with them portions of the top of the brick walls. The bottom chords of the truss, which were timber and not reinforced with steel, are broken and have fallen. The tension rod for this truss is sagging and there is a piece of scaffold hanging from it. All but one of the timber purlins connecting the truss back to the others are gone, but there are six steel angle braces back to the other trusses keeping truss T-1 upright.

Figure 2.10. Truss T-1. (STRATA 2020)

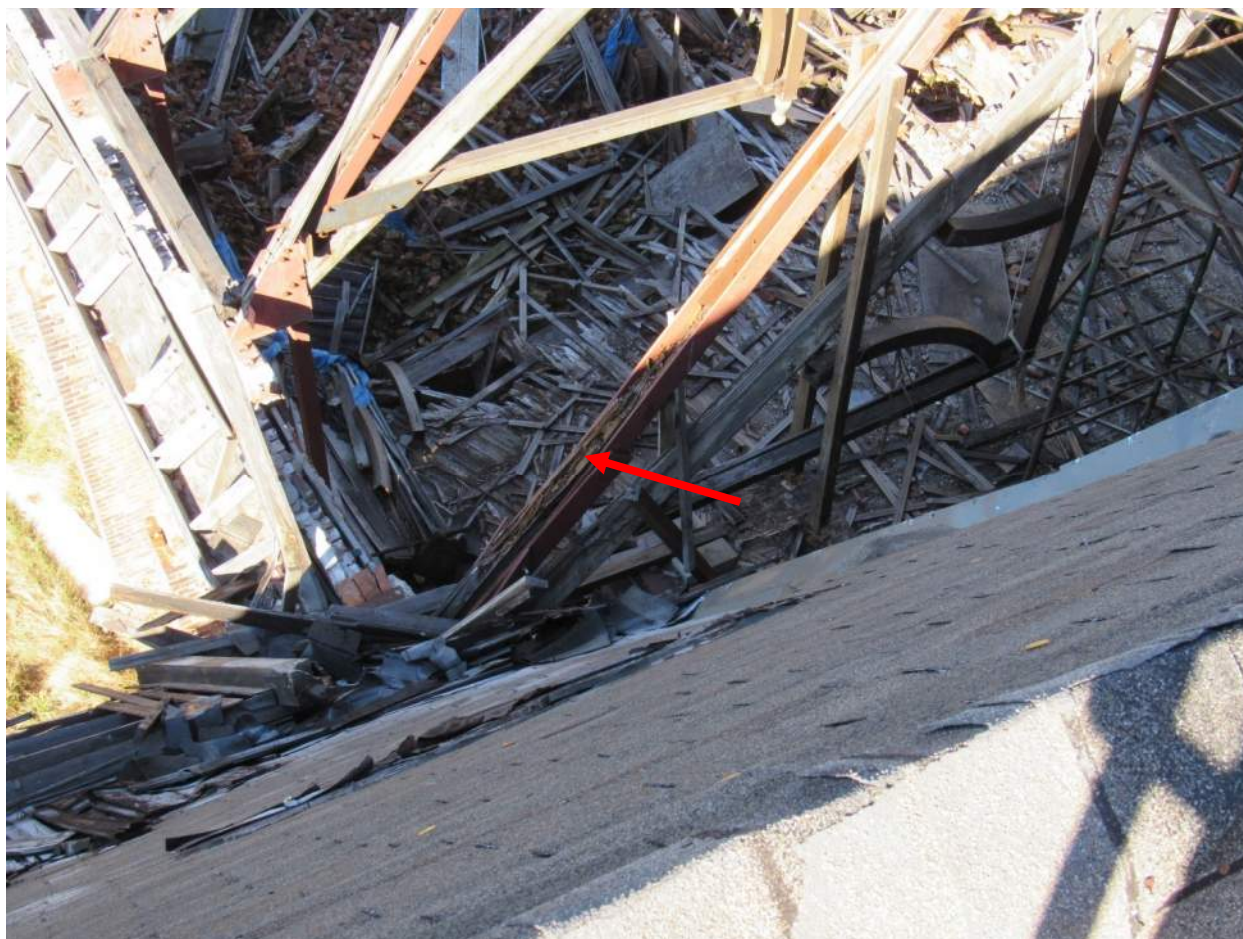
Truss T-5, which was only partially reinforced with steel, is visibly sagging along the top south chord. The timber here is rotted completely, the result of years of roof leaks in this area (Figure 2.11).

Figure 2.11. Looking down at south chords of truss T-5. (SEA 2020)

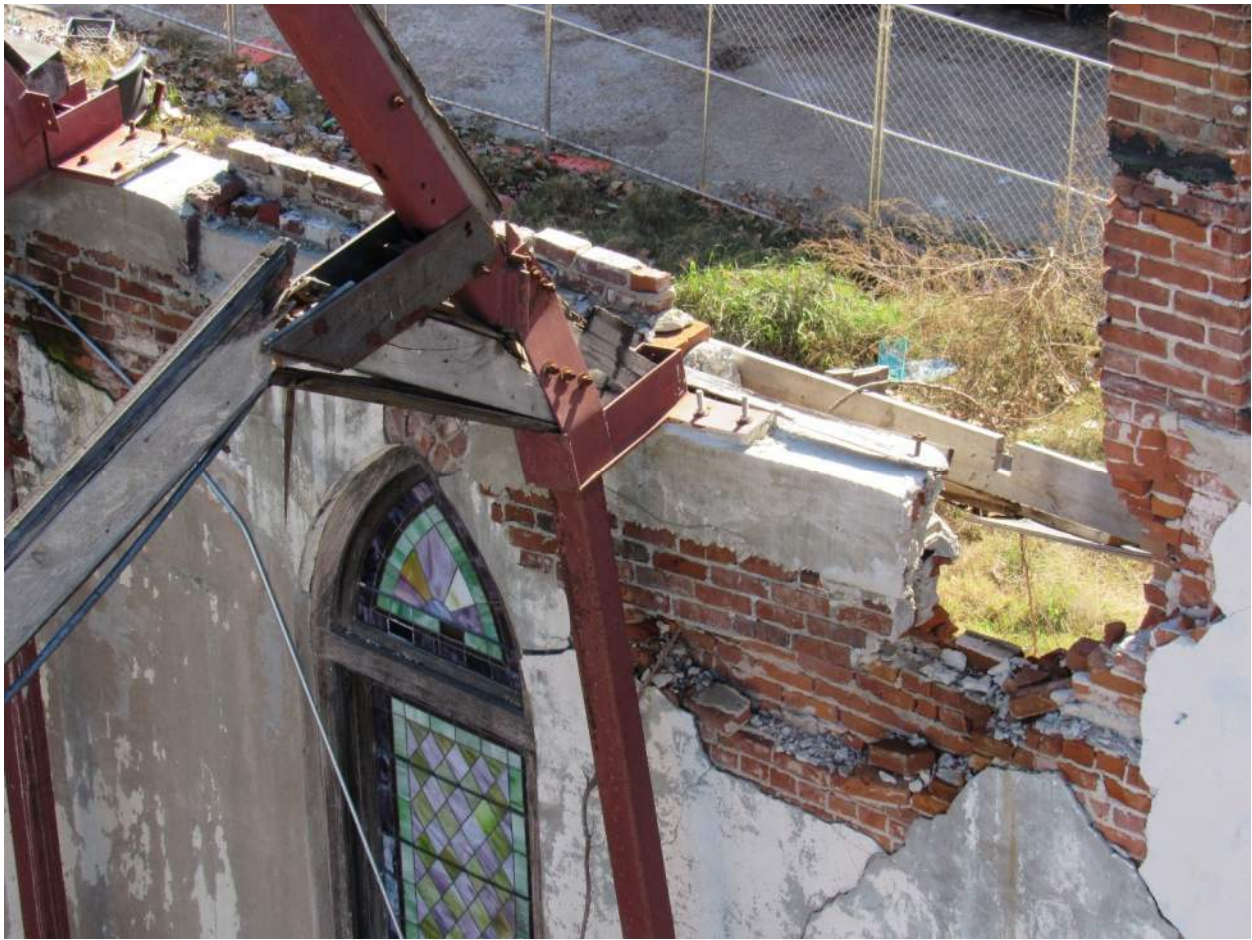
At the base of Truss 1 on both the north and south walls, a portion of the top of the wall has dislodged and come away with the truss (Figure 2.12). Truss 1 is located just to the east of the towers, and the brick that has come away also includes the corner of the towers where the towers meet the walls.

Figure 2.12. Base of Truss 1 at south wall. (SEA 2020)

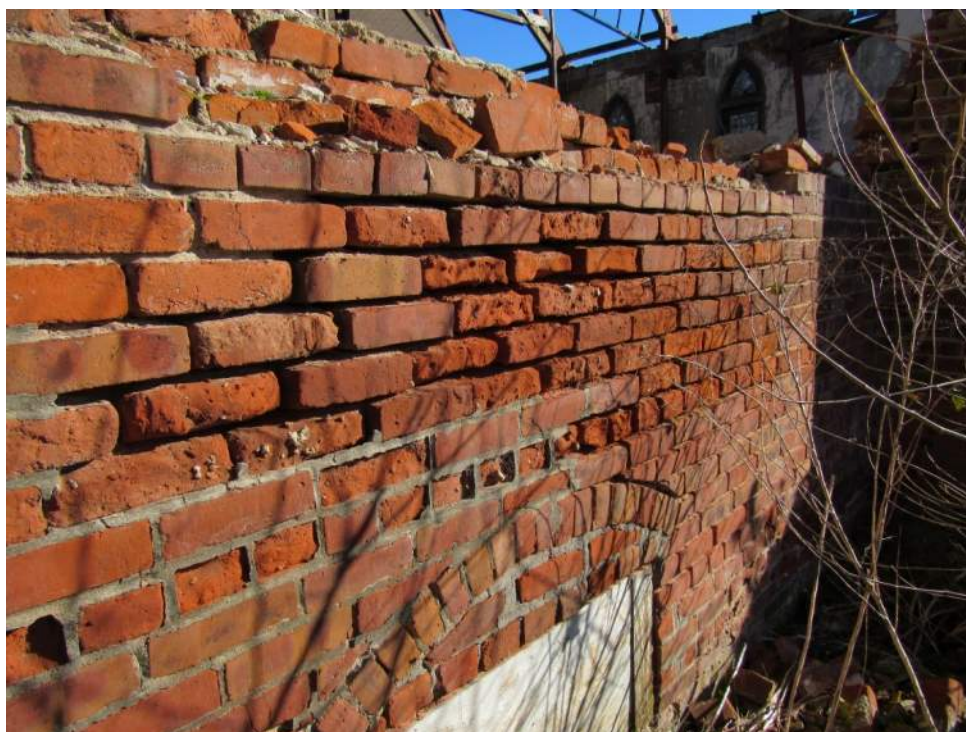
At the base of the west wall is an example of an area that has open joints and the faces of the bricks have spalled or eroded. There appears to have been some improper repairs to the mortar joints performed here some time ago. The joints were repointed using a modern, harder mortar, which has caused the bricks to deteriorate in deference to the mortar (Figure 2.13).

Figure 2.13. Eroded and deteriorated brick wall, west facade. (SEA 2020)

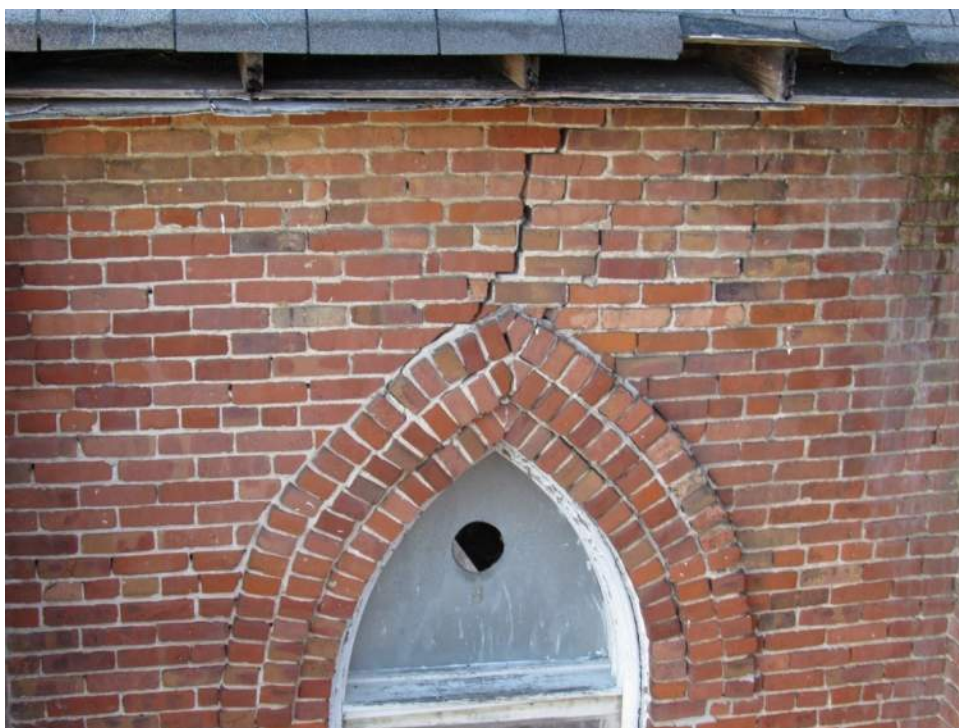
The walls have many tall, slender stained glass windows with blunt pointed arches. There are vertical cracks at the tops of some of these windows, which may extend through the full width of the wall (Figure 2.14).

Figure 2.14. Cracking over pointed arch window. (SEA 2020)

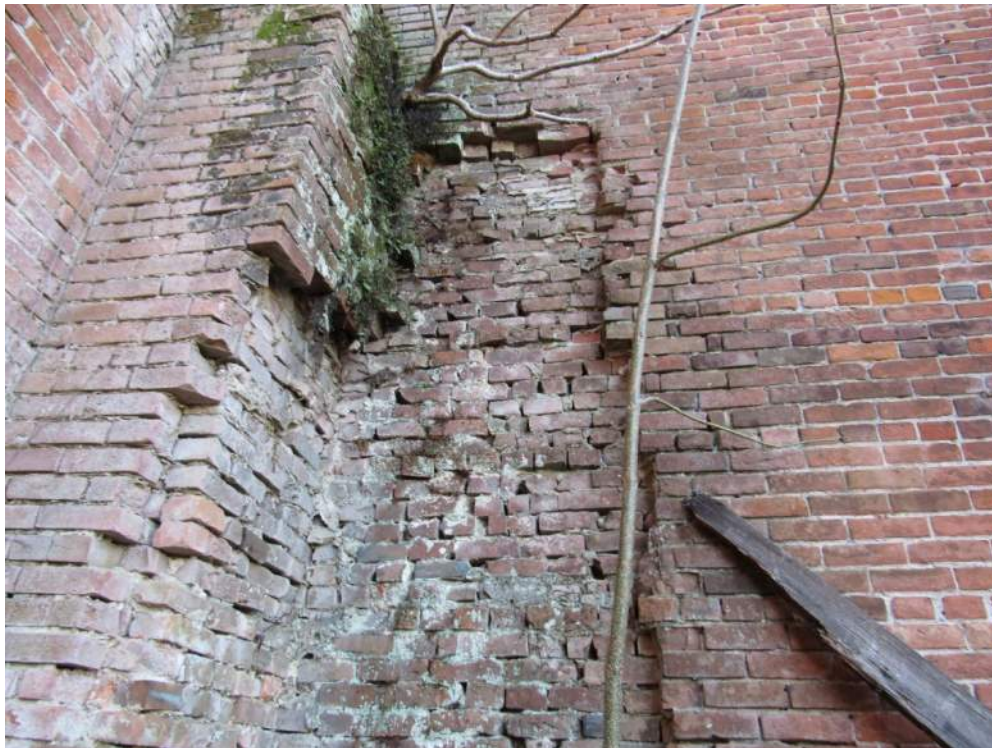
Figure 2.15. Outer wythe of brick removed at east wall on north tower. (SEA 2020)

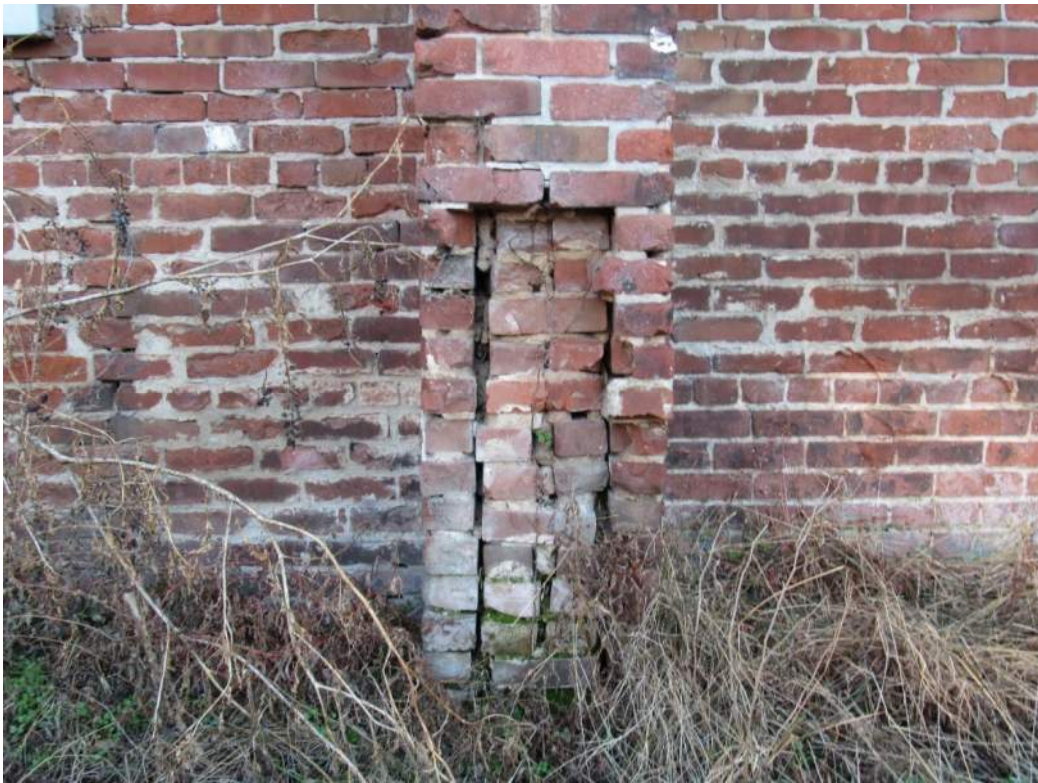
Figure 2.16. Base of buttress, missing bricks, open collar joints within. (SEA 2020)

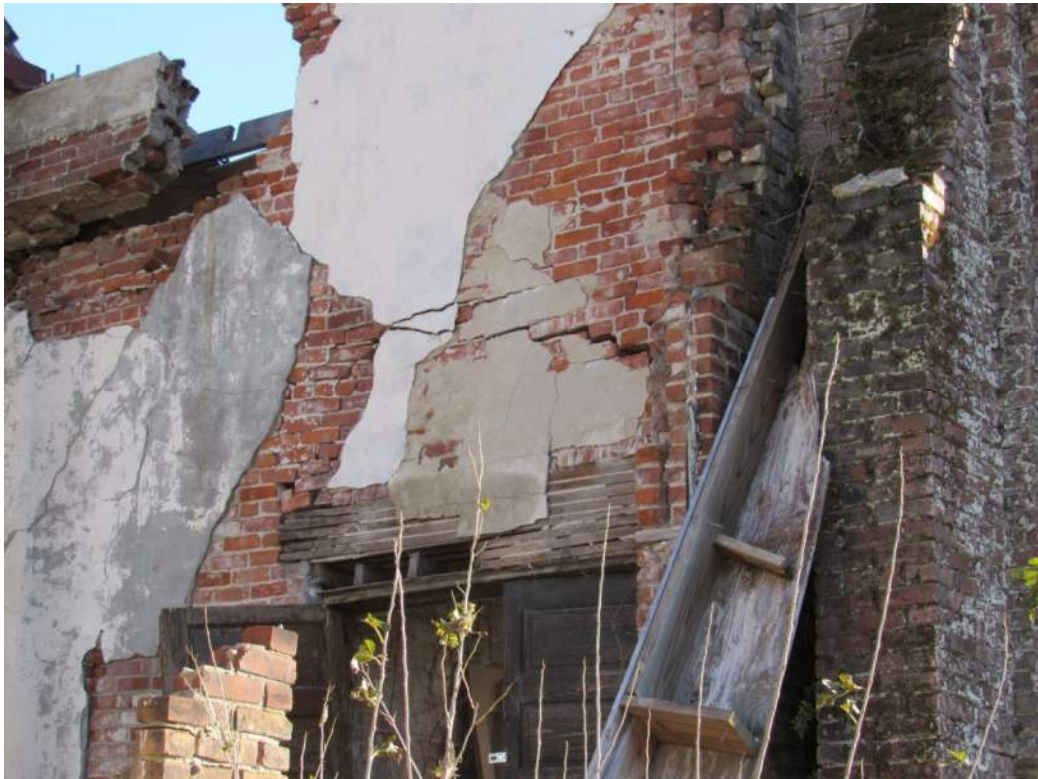
There is an area of brick that was observed over the lintel of the north door on the south tower. Here the lintel is wood-framed, and the brick above has clearly separated from the wall and is ready to fall (Figure 2.17).

Figure 2.17. Stepped cracks in bricks over failed door lintel on south tower. (SEA 2020)

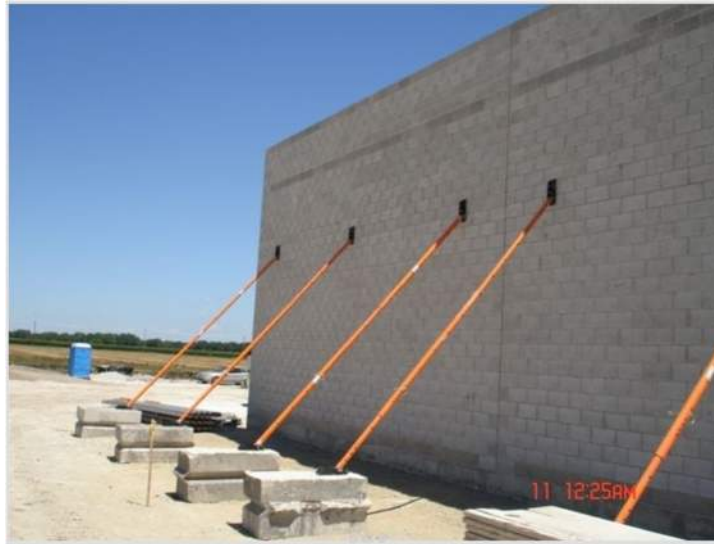
Figure 3.3. Example of temporary wall bracing at north and south transept walls. (ezgmfg.com)

Temporary bracing is recommended for the transept north and south walls to prevent them from collapsing outward. Work would involve placement of two braces at each wall. Braces would be installed with an aerial lift, anchored to concrete block bases, and connected to the walls near the tops of the buttresses. An example of this bracing is shown below (Figure 3.3). These braces would help to limit the collateral damage from a potential collapse of these walls. These braces would eventually be replaced with more permanent braces following removal of the roof framing and disassembly of the upper portions of the gable walls.

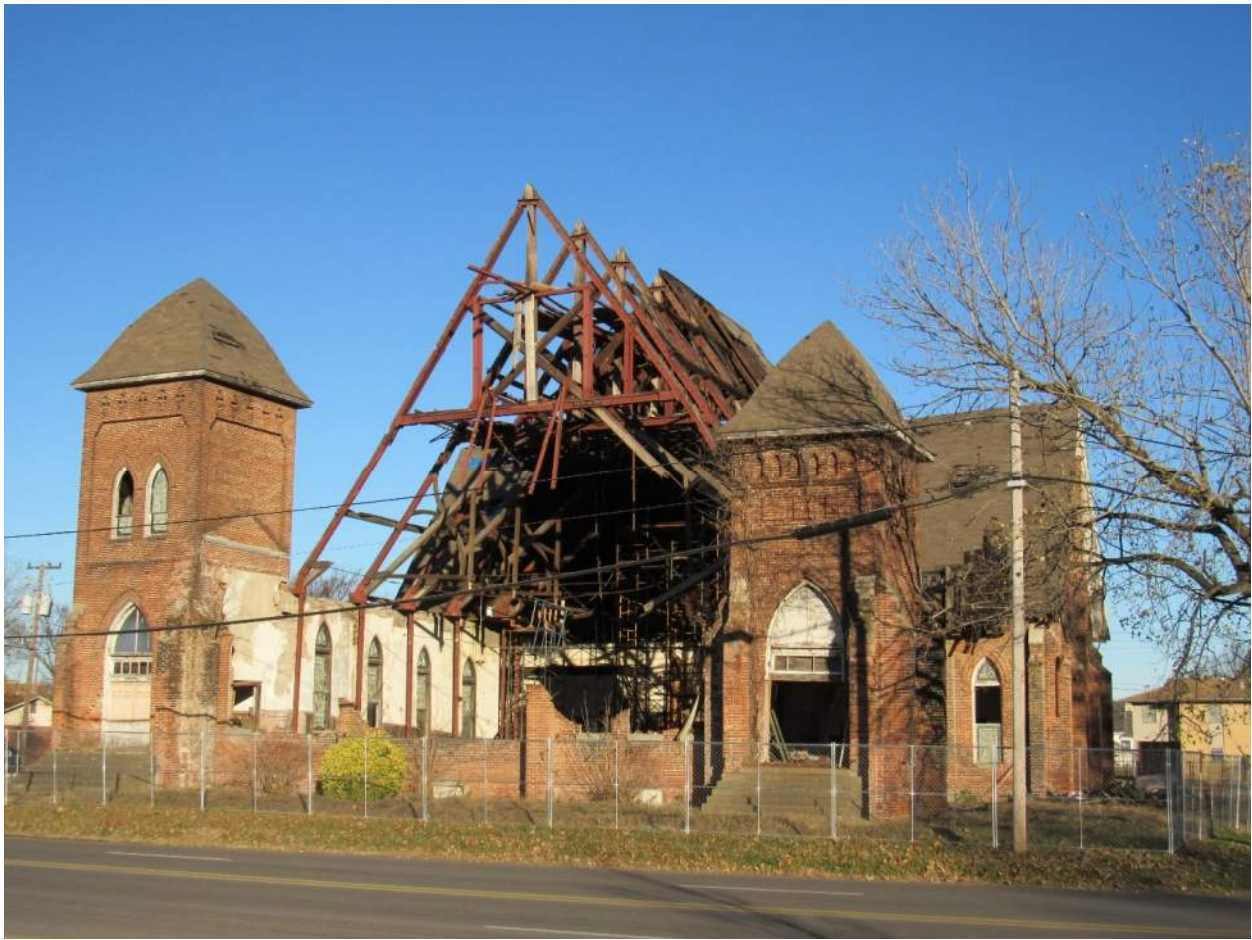
Figure 3.4. West side of church from across Columbia Street. (SEA 2020)

The demolition of the roof framing would likely be performed using workers on two or more aerial lifts in conjunction with a crane. At least one lane of traffic would need to be closed on Columbia Street for the crane. Work should be performed under the direction of a structural engineer (experienced with historic masonry and timber structures), to direct the sequence of removal. The progression of disassembly would likely involve removal of roof trusses one at a time. A worker in an aerial lift on either side of the truss would connect cables from the crane to the truss. Each truss would be picked by the crane, while workers on lifts would cut connections of the individual truss to the columns and cut lateral connections to adjacent trusses. Since the nave truss T-1 appears to be the most precarious, this would likely be removed first (Figure 3.4).

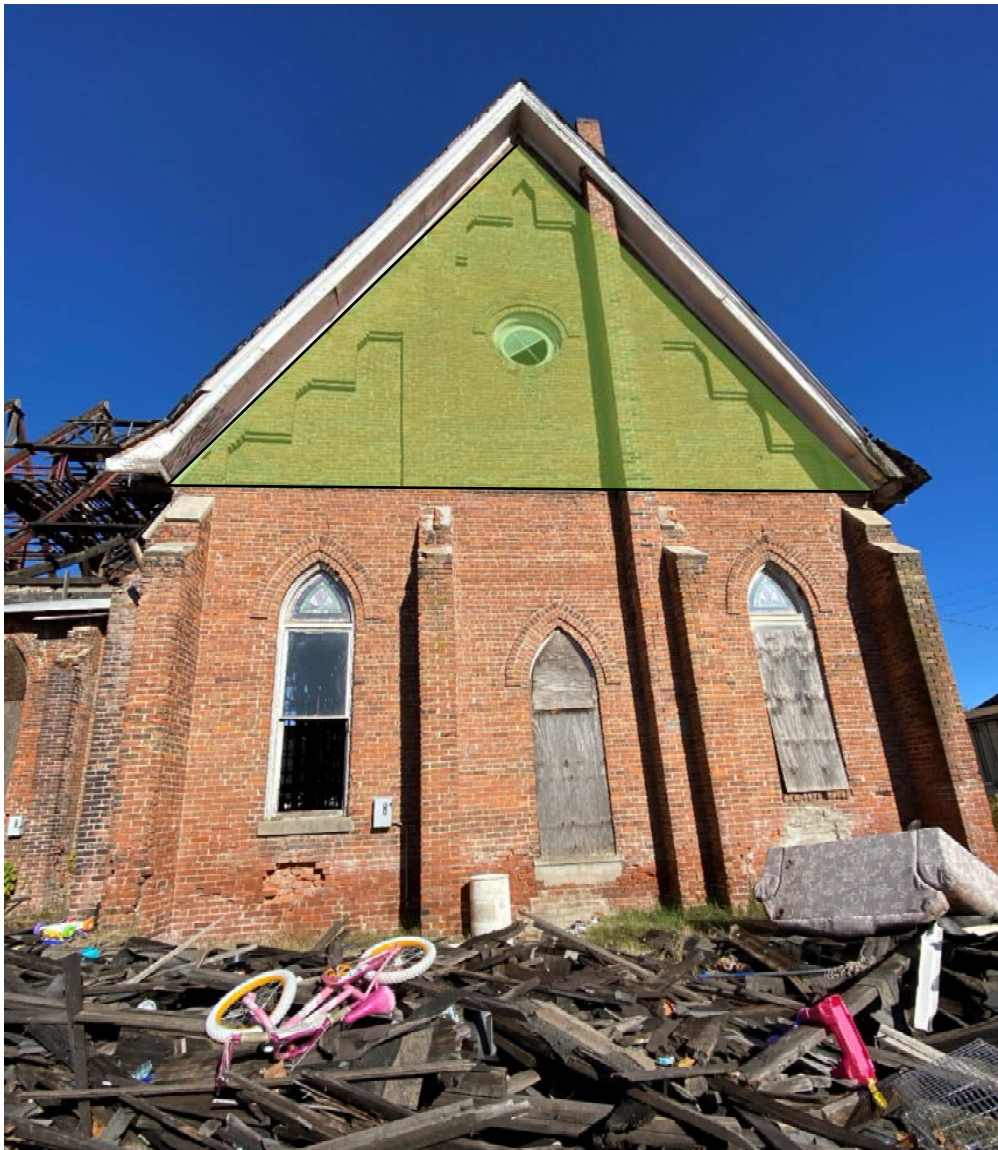
Figure 3.6. South gable end of transept. Area to be disassembled is shaded in green. This work would be duplicated on the north transept wall. (STRATA 2020)

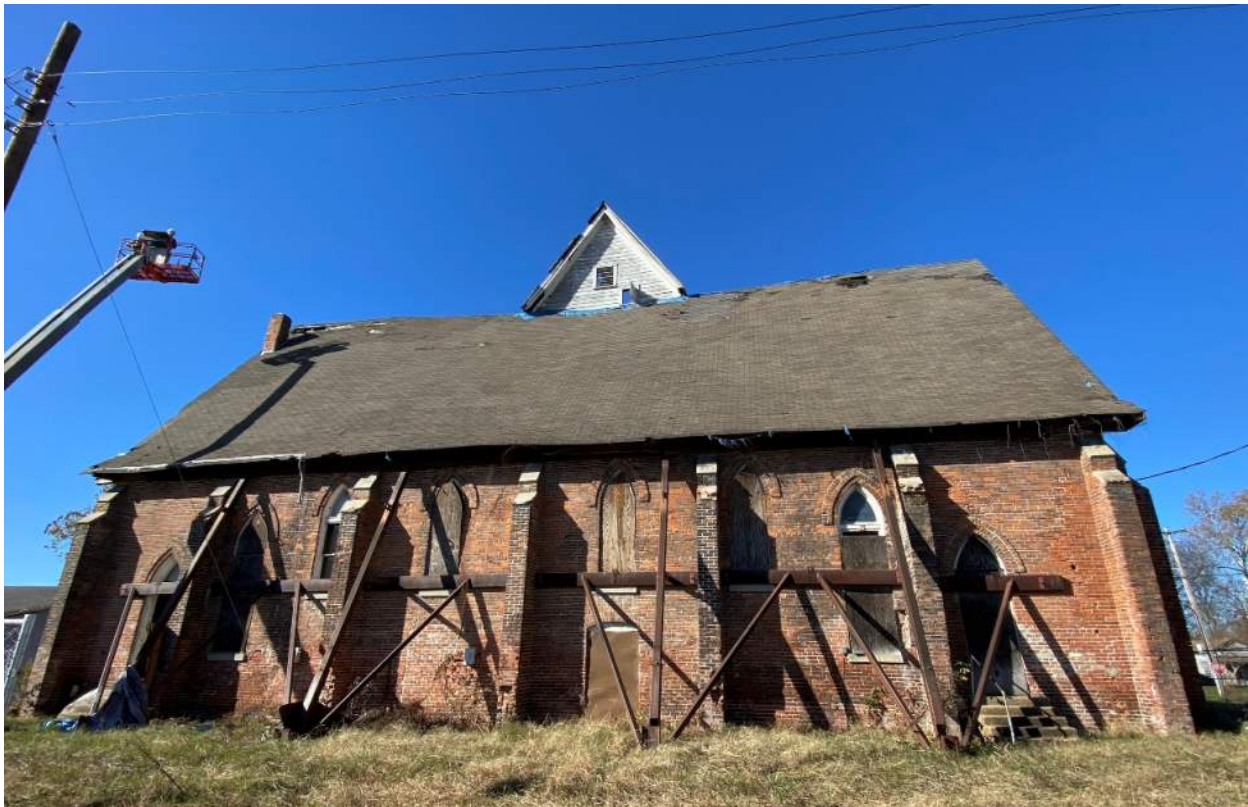
Figure 3.7. Current bracing configuration on east wall. (STRATA 2020)

A total of 11 new braces would need to be installed for the north and south nave walls and the north and south walls of the transept, while the bracing on the east elevation would remain in place. Installation would require the use of an aerial lift and a truck-mounted crane for lowering steel into place on both the inside and outside of the masonry walls. The anticipated time of installation would take 2 weeks.
